# Seismic Risk Assessment

**Subject Property:**  
**City Place Apartments**  
[REDACTED], Seattle, WA 12345

Re: Seismic Risk Assessment (SRA) – Probable Maximum Loss (PML)  
City Place Apartments  
██████████, Seattle, WA

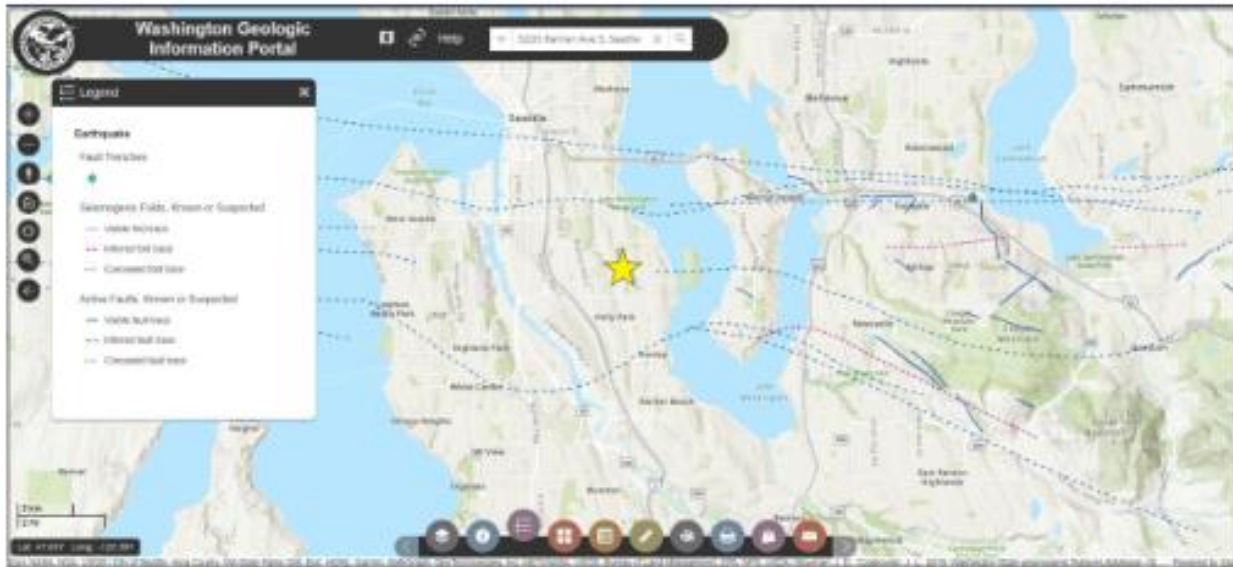
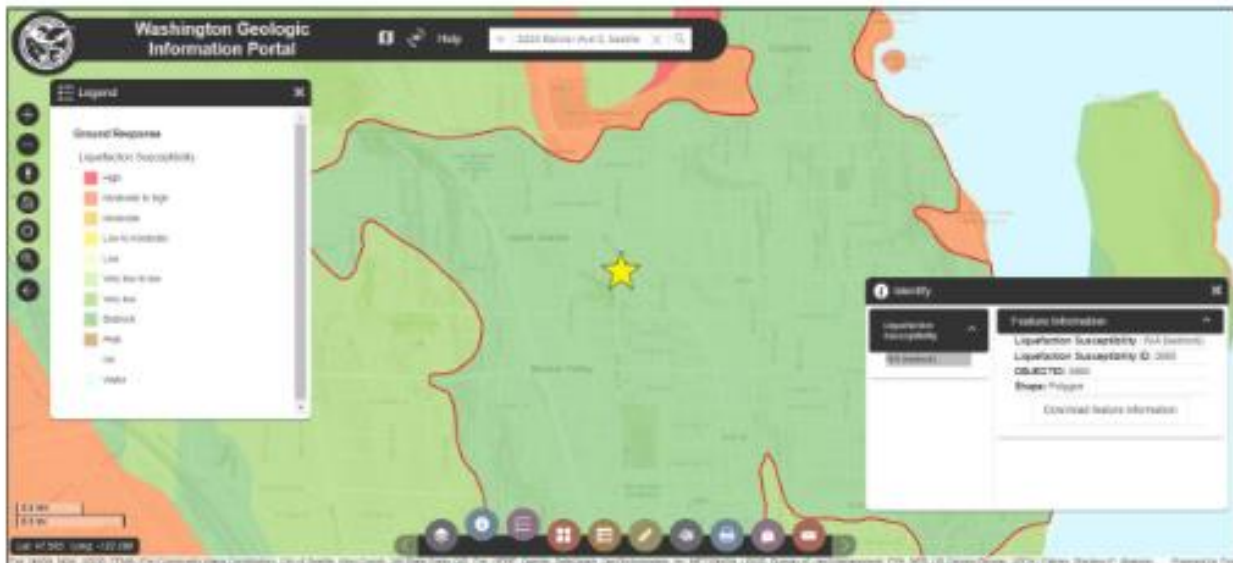
**FIGURE 2**

In accordance with the ASTM Standard Guide E2026-16 and Standard Practice E2557-16, a Level 1 Site Stability Assessment was performed by review of publicly available records. Based on our assessment and review of generalized mapping, the potential for liquefaction at the site appears to be low during a DBE event. Therefore, the Subject Property appears to meet the site stability requirements.
